## Work Health & Safety

### URGENT Safety Alert

#### Preliminary incident summary

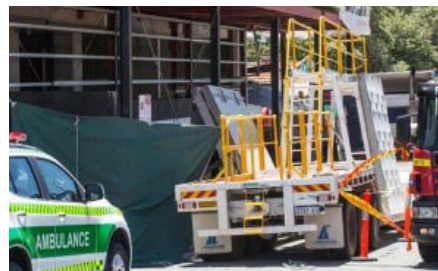
Whilst a thorough formal investigation is being carried out by WorkSafe WA, we understand that the project, Foundation Housing in West Perth, was being constructed by Jaxon Construction. We believe that three panels had been loaded on each side of an A-frame truck and transported to site. It is alleged that restraint chains on the panels were removed to allow unloading and three of the panels were lifted off the truck from the high side only. During unloading, the truck appears to have been on a slight lean towards the footpath, due to the camber of the road. As the third panel was lifted from the high side, initial reports of the incident suggest that the unbalanced load caused the three panels on the low side of the truck to overturn.

Fortunately, two of the falling panels appear to have collided with a steel column to arrest their fall, however the third single panel seems to have missed the column and fell to the ground, crushing the two workers who were sitting near the truck on a concrete kerb on the footpath, eating their lunch.

- Particular attention should be given when loading, separating, supporting and protecting the elements so as to prevent damage and permit safe unloading (AS 3850.2:2015, Clause C4.1.2).

- During unloading, the delivery vehicle shall be on firm ground and, if necessary, blocked to prevent tipping when partially unloaded. Where the unloading sequence could lead to instability of load, elements shall be individually restrained and the loading configuration shall be checked to ensure that removing individual elements does not result in instability of the load and/or the vehicle (AS 3850.2:2015, Clause 4.1.3 ).

- Where the site is not level, unloading should be commenced from the low side, once again taking care to prevent tipping when partially unloaded (AS 3850.2:2015, Clause C4.1.3).

- Vehicle stability during unloading shall be considered prior to restraints being removed (AS 3850.2:2015, Clause 4.1.3).
